Kalamazoo River Area 3 Supplemental Sampling Oversight

PREPARED FOR: James Saric/USEP
PREPARED BY: Dave Shekoski/CH2M HILL
Jeff Keiser/CH2M HILL
DATE: September 2, 2013
PROJECT NUMBER: 422494.FI.01

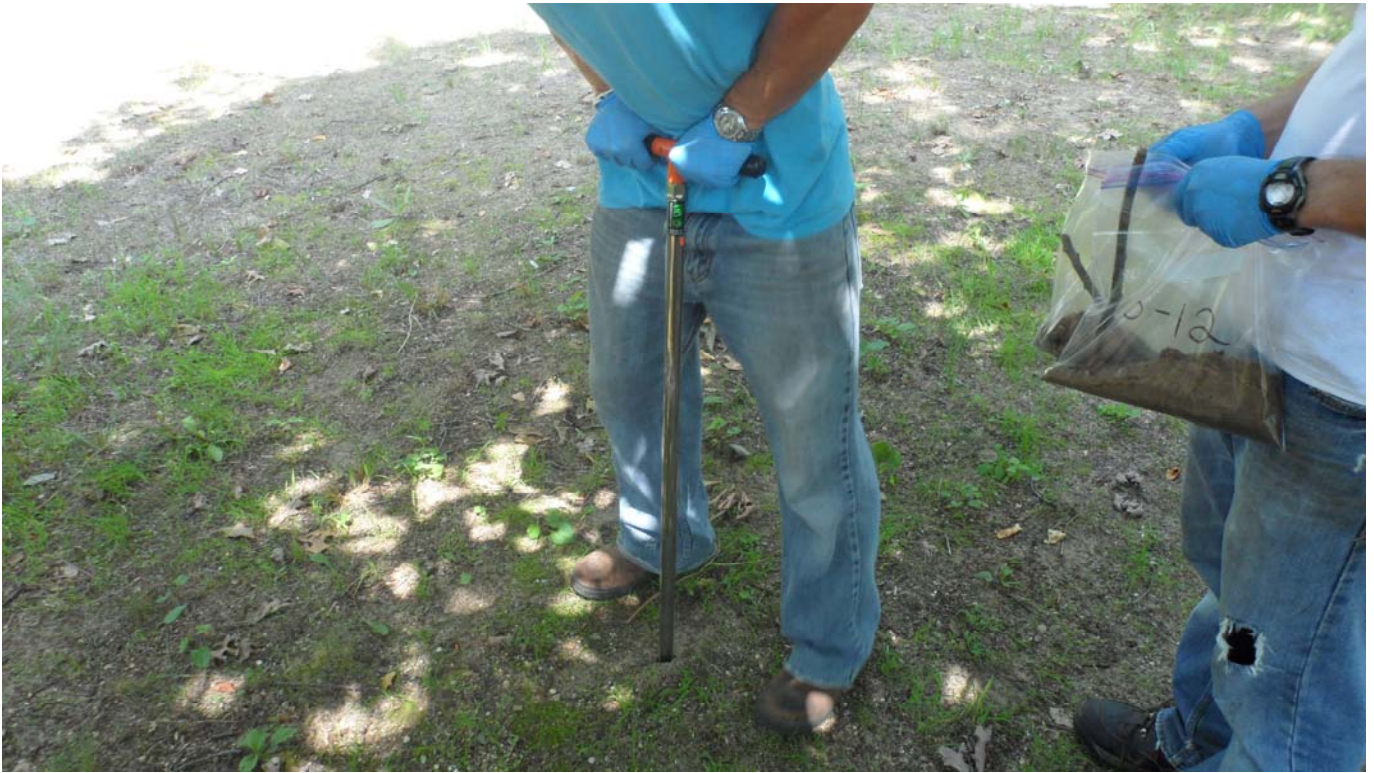
Photo 1, Hand core

Decontamination of equipment as observed by CH2M HILL consisted of an Alconox wash and distilled water rinse. The entire hand corer was cleaned with a scrub brush. The end section was unscrewed and the threads were scrubbed. Decontamination was performed on the DU where the samples were collected to prevent distributing contamination between DUs. When gray material was found it was assumed to be a visual indicator of elevated contamination, so decontamination was performed where the gray material was observed to prevent spreading contamination to cleaner areas.

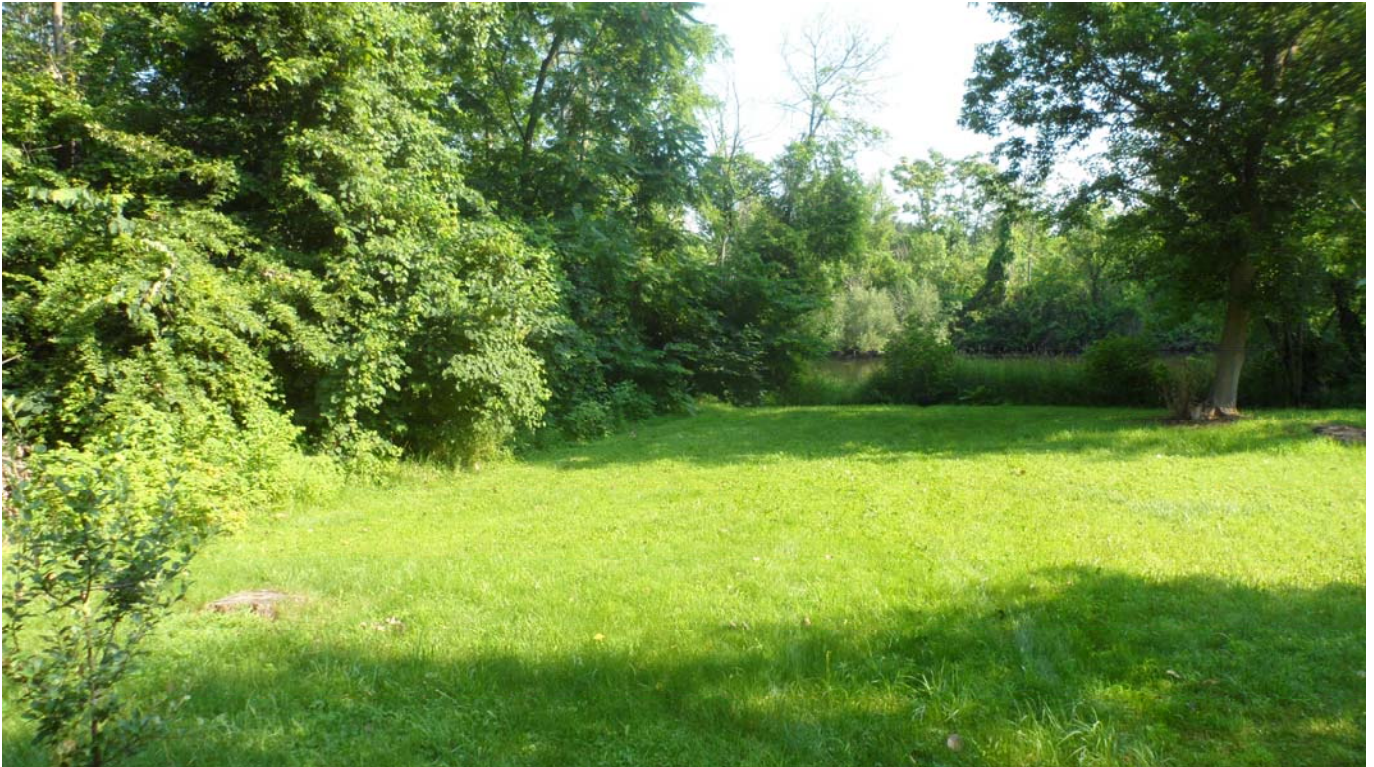
The property at 362 Water Street (DU-05) contains a small section that runs the length of the property which is about 10 feet wide and heavily vegetated (Photo 2), while the rest of the property is mowed grass. AMEC decided to exclude this thin piece of land from the sampling area because:

Photo 2, Area excluded at property 362 Water St.

- *The heavy trees and vegetation would make it extremely difficult to move around in*
- *It would be dangerous with fallen tree branches hidden by high vegetation and heavy growths of poison ivy*
- *This thin piece of land was not impacted any differently than the area that is being sampled therefore there would be no real benefit added by including it*
- *AMEC still collected 48 samples*
- *The width of the section not included is ~10 feet, which is smaller than intervals between the grid rows.*

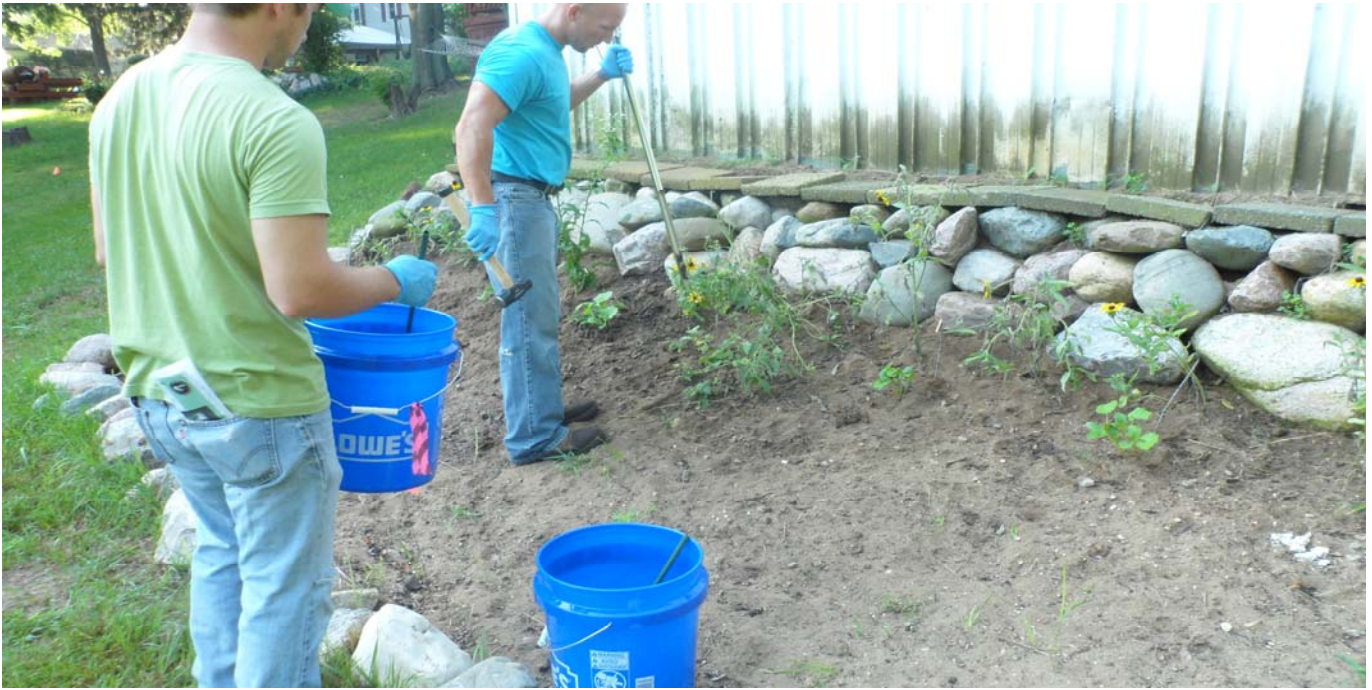
At 346 Water Street (DU-07), a small garden with flowers is in back of the garage (~5 ft. x 18 ft.). One of the sample locations was in the garden (Photo 3), so the question was raised whether the soil was appropriate to include in the DU sample set since it could be non-native soil. It was decided that it should be included in the incremental sampling because there is visual evidence suggesting that the soil is the same as the surrounding soil, and there is no evidence that it is different. The soil is poor grade sandy soil, similar to native site soils.

Photo 3 Garden sampling

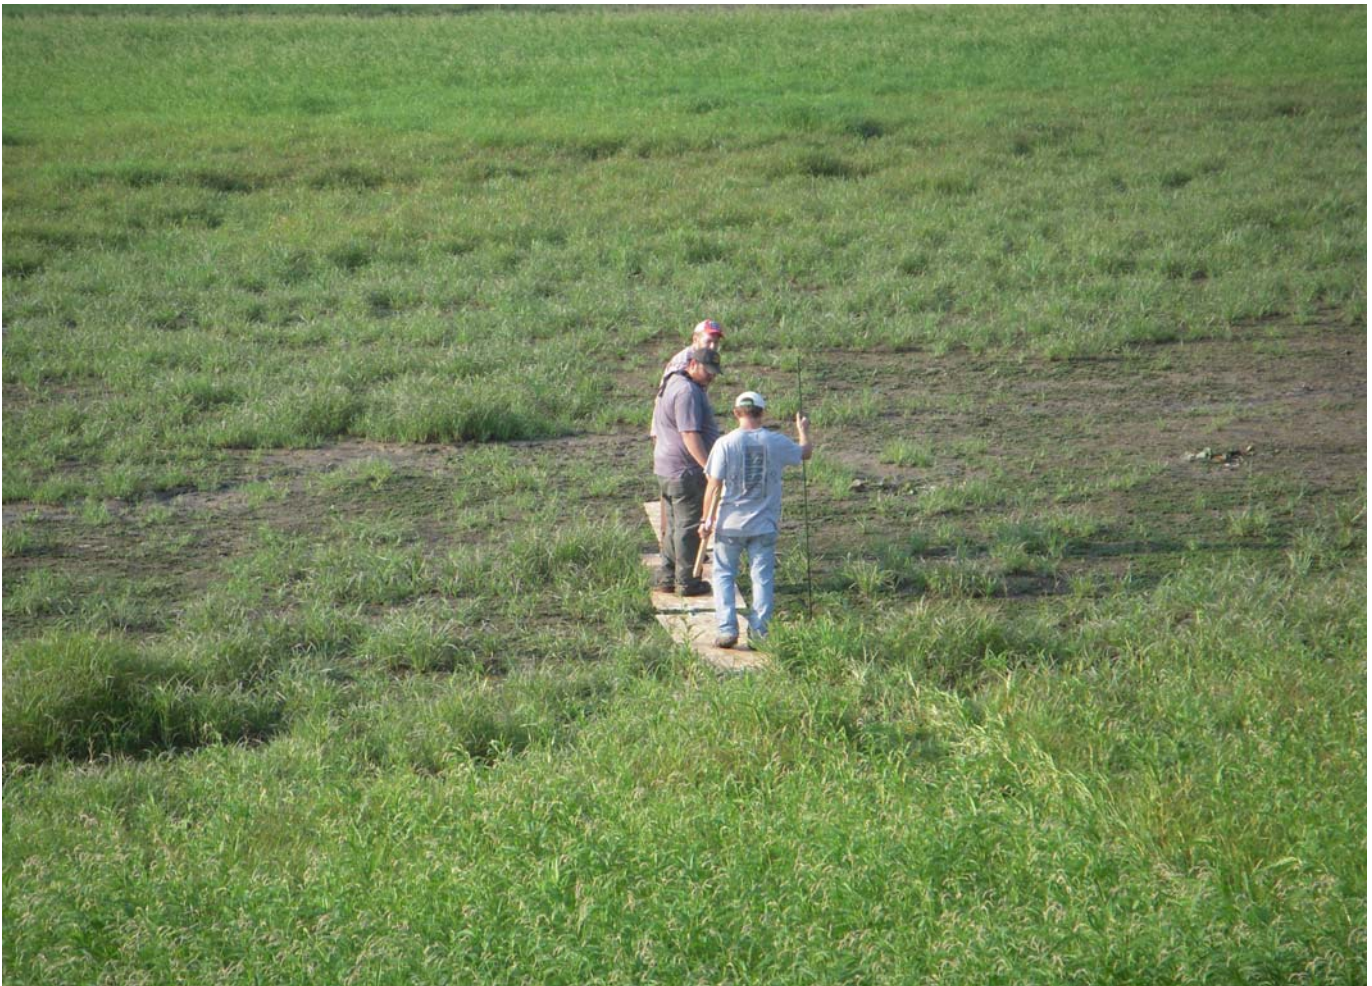
The same AMEC personnel were on site for the second mobilization. Sediment was still dangerously soft and very deep (based on poling). AMEC used three 2' x 8' plywood sections which were laid on the sediment surface allowing them to walk to the sampling locations (Photo 4). A small jon boat with the equipment inside was pulled along the surface on the east side of the impoundment, but was abandoned on the west side because of high vegetation. Due to the limited space on the plywood sections, CH2M HILL observed the sampling from the edge of the impoundment. Binoculars were used to enhance the observation of details of the sampling activities.

Photo 4, Pine Creek sampling
